Appendix B
Materials Analysis:
Paint
Mortar and Salts

Historic Building Architects, LLC

APPENDIX B - MATERIAL ANALYSIS

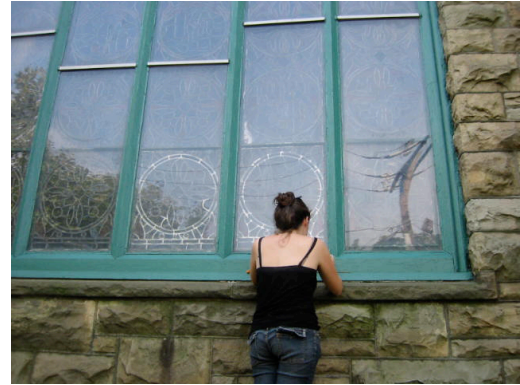
The removal of the sample from the window muntin.

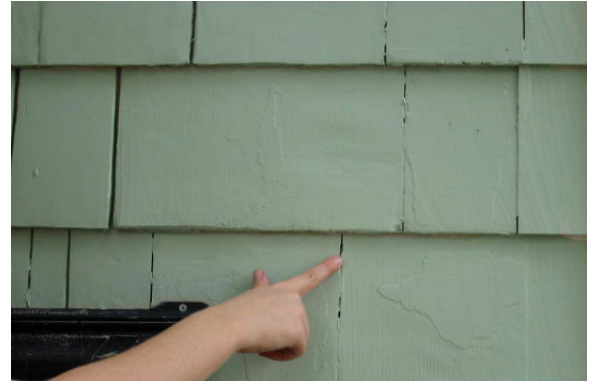
Sample location on the east facade of the Parish Hall.

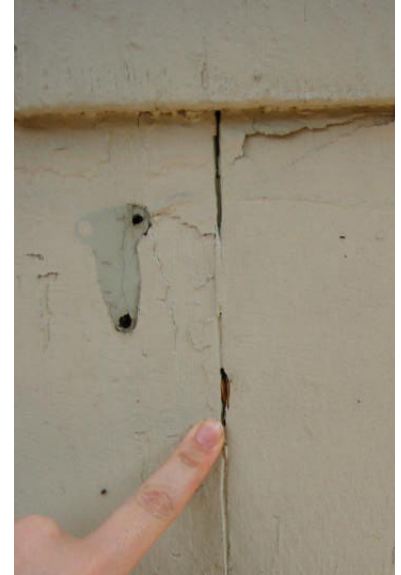
Sample location on the east facade of the Parish Hall Link.

The first paint layer seen is a variation of the mauve used previously on the church and Parish Hall.

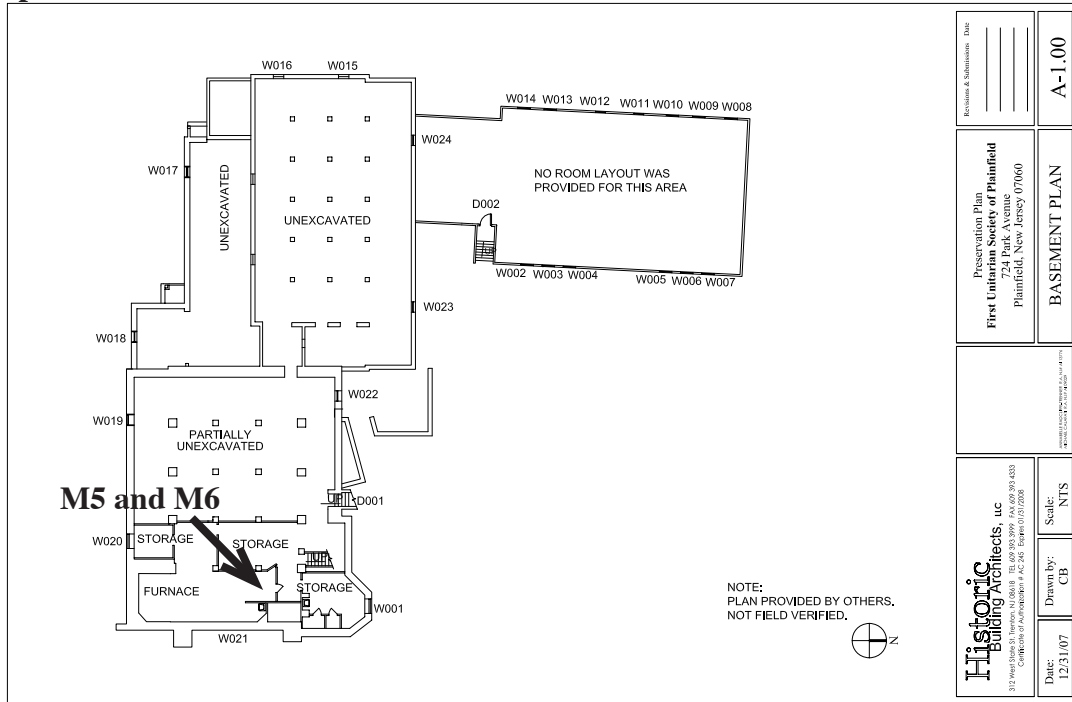
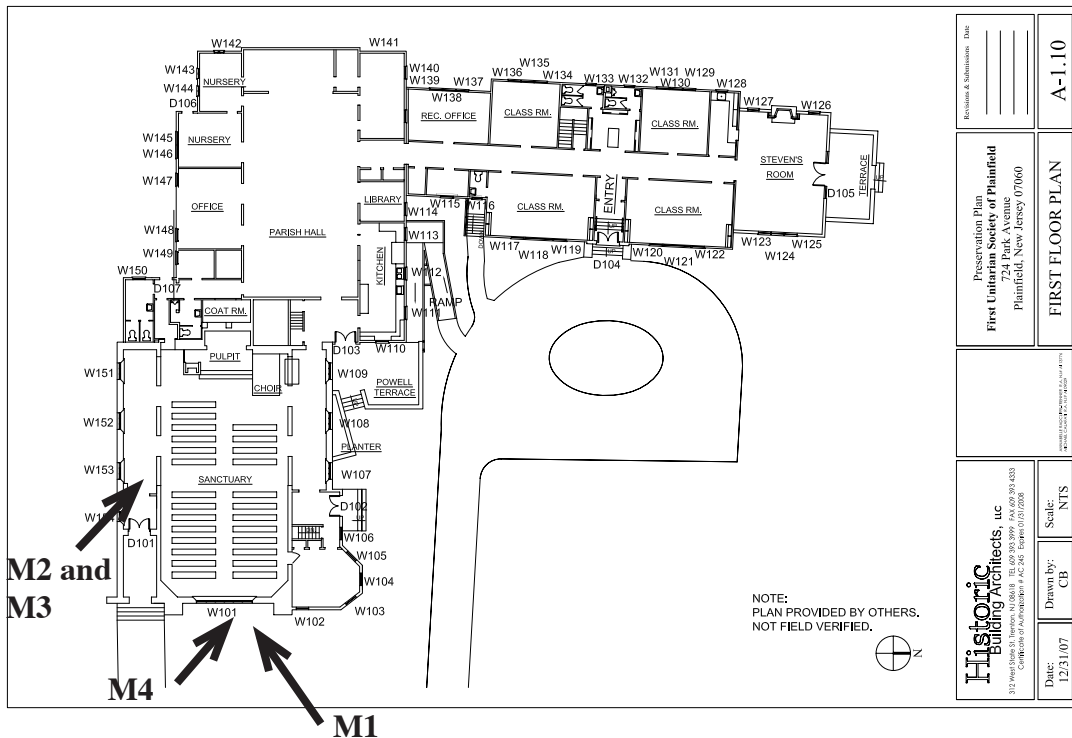
Sample Locations

The exterior of the Church is made up largely of mortar sample M1, which is a grey color and most likely contemporary probably dating to the 1981 restoration of the Church. The softer, lighter mortar found on the masonry wall beneath the porch on the Park Avenue elevation appeared to be older than the more predominant grey mortar. This assumption was based on its condition, softer lime mortar like appearance, and its sheltered position under the porch. A bedding mortar sample (M2) and a pointing mortar sample (M3) were removed from this wall.

It is strongly recommended that any future repointing methods recreate these mortars, matching in color, texture, and type based on this analysis.

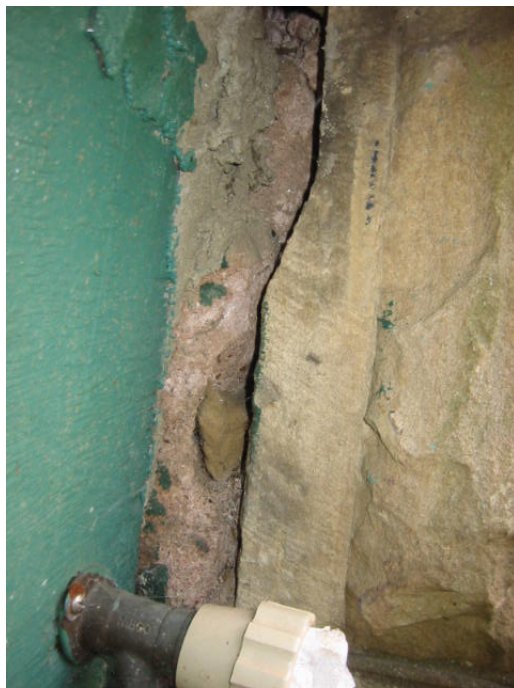
Sample M4 (Left) - Mortar found in the joint between the wood board and masonry wall in the basement window below the Robinson Window.

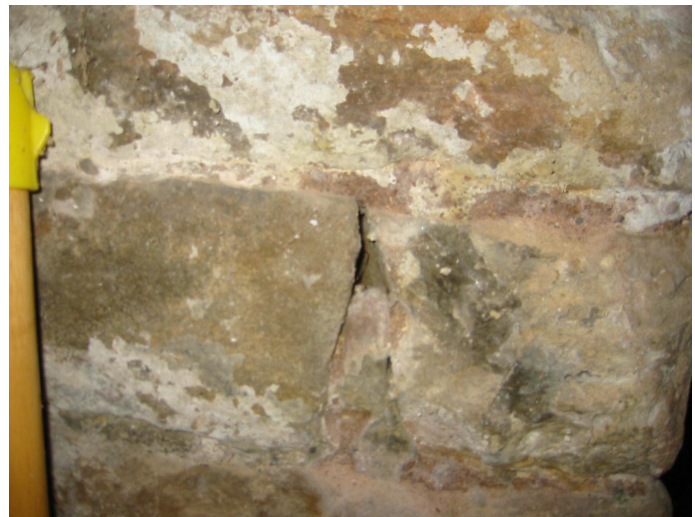
Samples M5 and M6 (Above) - removed from the interior basement wall.

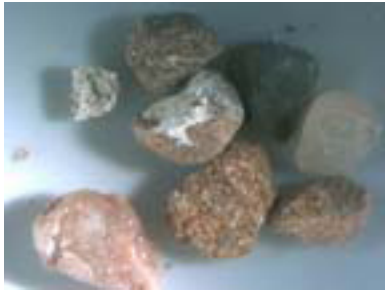
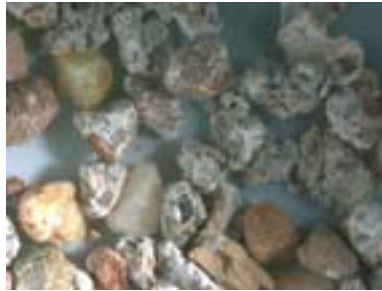
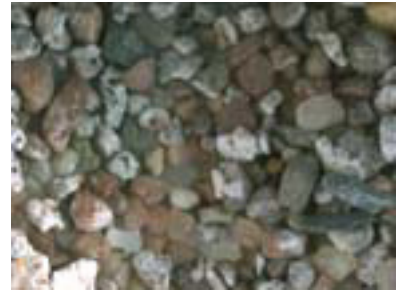
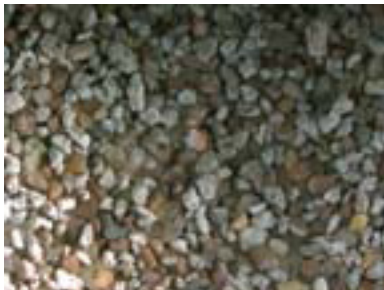
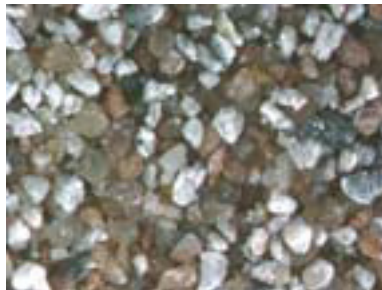
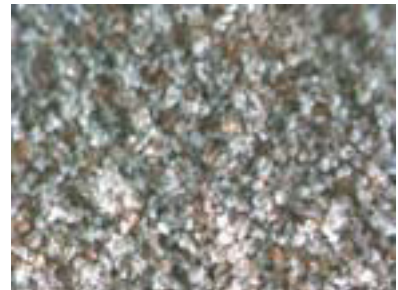
Historically bedding and pointing mortar were of the same mix, but while microscopic analysis of samples M2 and M3 showed the two mixes to be very similar, they are not the same. The bedding mortar is a lime based mortar, light grey in color. The pointing mortar contains cement in the mix and is a slight variation in color, light grey brown. Both samples showed the same red brown aggregate of crushed brick and/or rounded bits of sandstone and larger pieces of rounded quartz. The pointing mortar has the additional pieces of angular aggregate and grains of Portland Cement that were broken up during the grinding process but were never dissolved like the more soluble lime.

The bedding mortar is a lime mortar with a 1:3 ratio of lime to aggregate. The pointing mortar contained cement that was not completely broken down by the grinding process and acid dissolution used in gravimetric analysis. When the aggregate was sieved after the gravimetric analysis, some of the gravel in screens 8 and 12 contained what should have been smaller aggregate bonded together into larger pieces by cement. This may have thrown off the aggregate to cement to lime ratio. The pointing mortar may therefore be a Type O or N mortar. This mortar would contain 1 part cement, 1 to 2 parts lime, and 5 to 9 parts aggregate.
